Release Notes — Software Release 7.1.1 Avaya Ethernet Routing Switch 8800/8600

7.1.1
NN46205-402, 07.03
September 2011

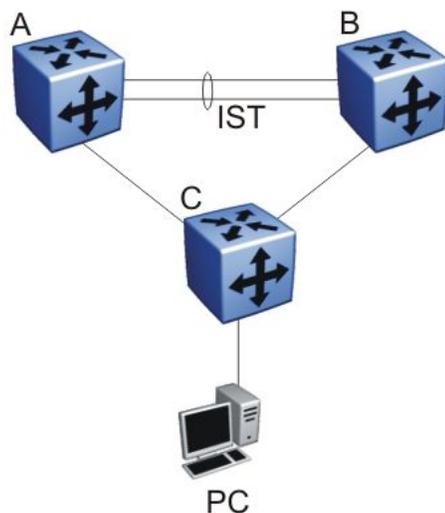
Figure 1: SMLT upgrade scenario

Consider the following figure, showing a triangle SMLT setup. In this case, the user intends to upgrade the IST peers (that are currently running 5.1.0.0) to 7.1.0.0.

Assume the user Telnets from the PC to manage switch A and switch B. When the Telnet traffic generated by the PC arrives at switch C, depending on the MLT hashing algorithm, the traffic can be hashed to the link toward switch A or switch B. So, it is possible to have a situation

where the Telnet management traffic destined for switch A flows through switch B and vice-versa.

In scenarios 1 and 2, you can manage the switch effectively at all times during the upgrade, and therefore these scenarios require no additional considerations. However, in scenario 3, you can lose Telnet connectivity during the upgrade of the IST peers unless you follow the proper steps.

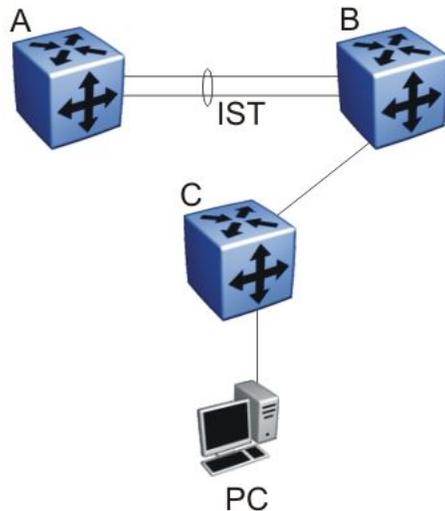
Figure 2: SMLT upgrade scenario after upgrading switch A to 7.1.0.0

Assume that the user upgrades switch A to 7.1.0.0. Due to the SMLT behavior, the network diagram now looks like the following figure.

In this situation the PC cannot communicate with switch A, and as a result Telnet access to switch A is unavailable. For in-band management, you can alternatively Telnet first into switch B, and then Telnet to switch A from there.
